National Transportation Safety Board

Multi-Vehicle Crash in Mountain View California
(March 28, 2018)

Talking TIM Webinar (May 2020)

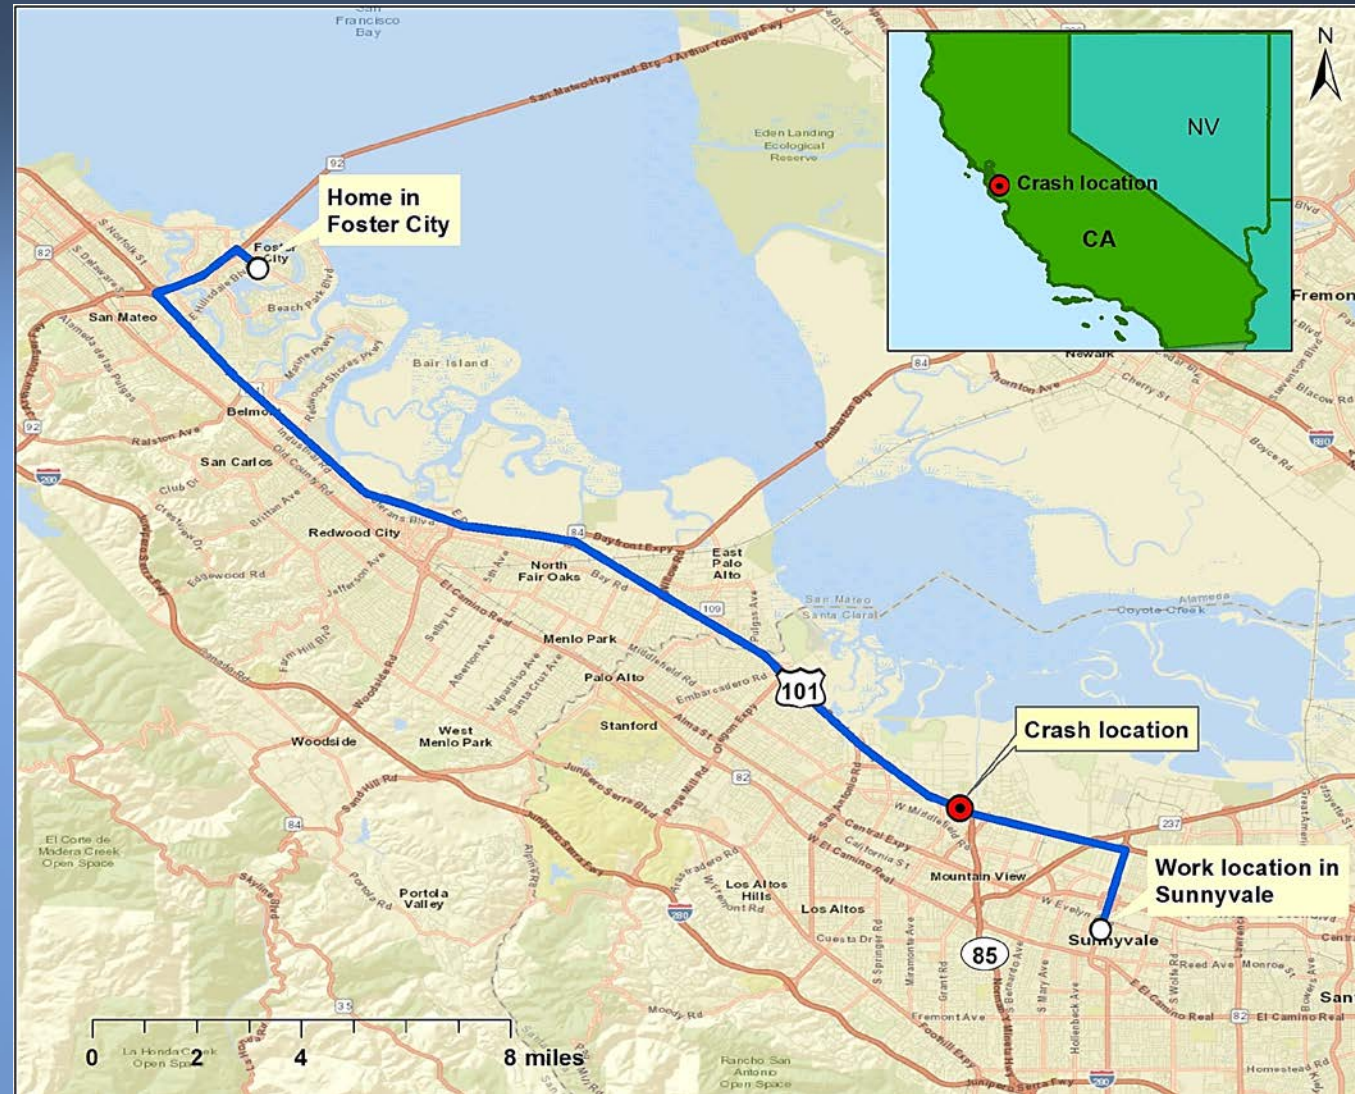
Mountain View

- Friday, March 23, 2018
- 9:27 a.m.
- Mountain View, California
- US-101 / SR-85 interchange
- 2017 Tesla Model X SUV
- 38-year-old driver
- Partial automation “Autopilot” engaged

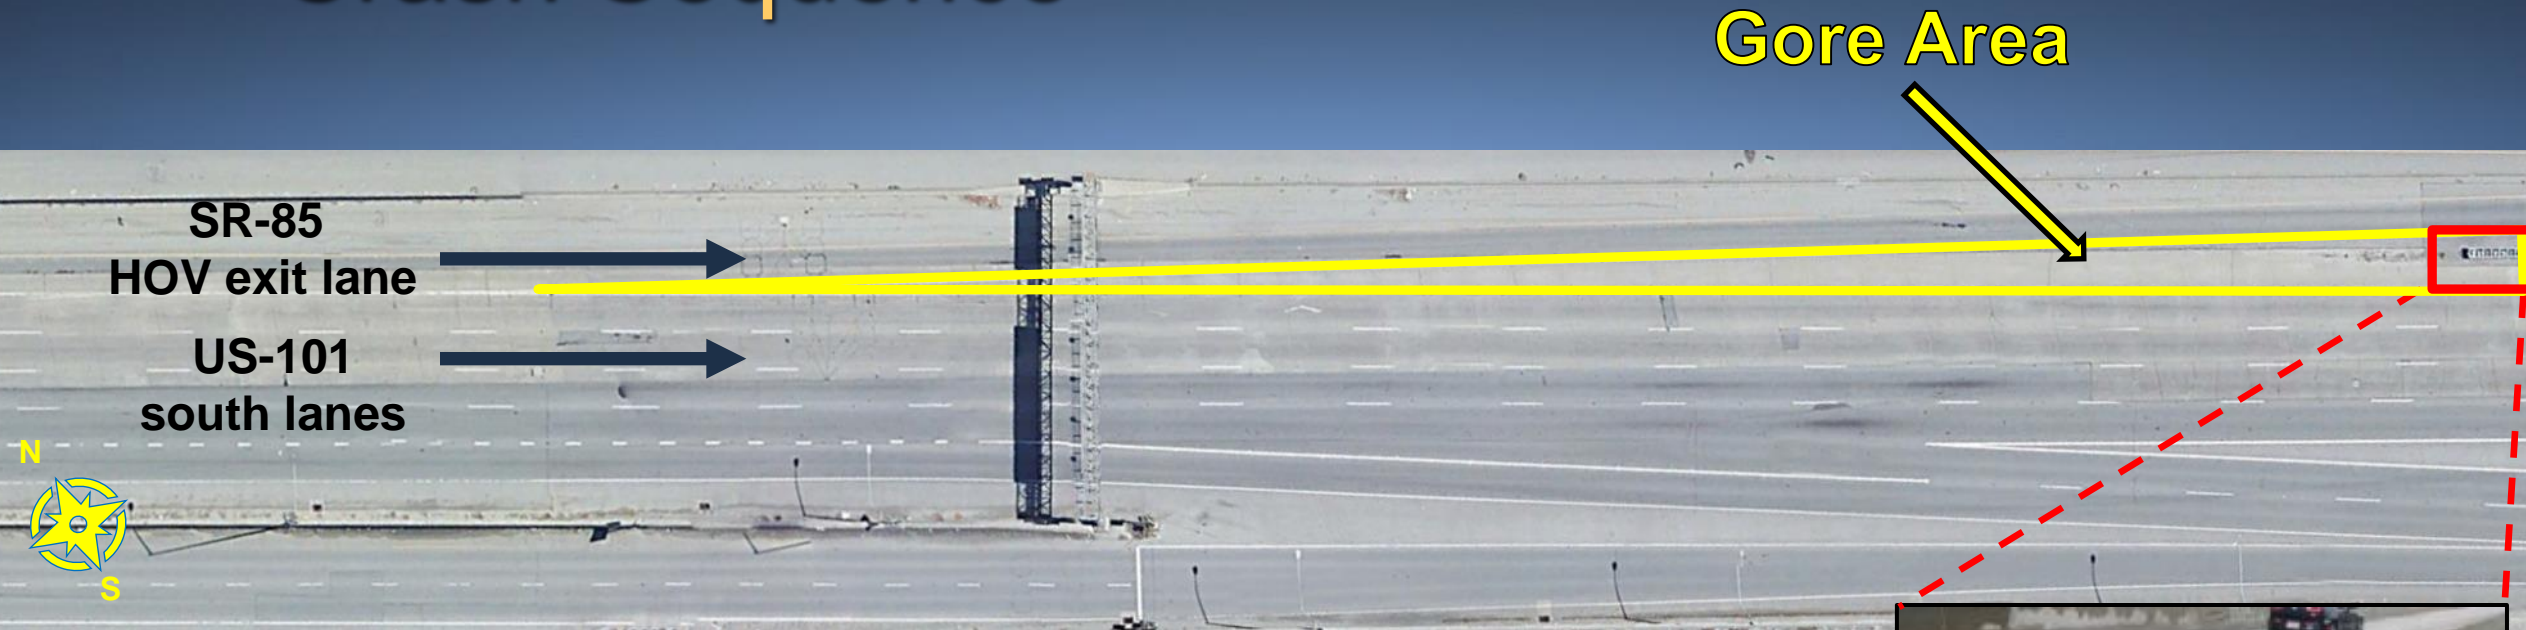
Crash Sequence

Crash attenuator was collapsed and nonoperational prior to the crash

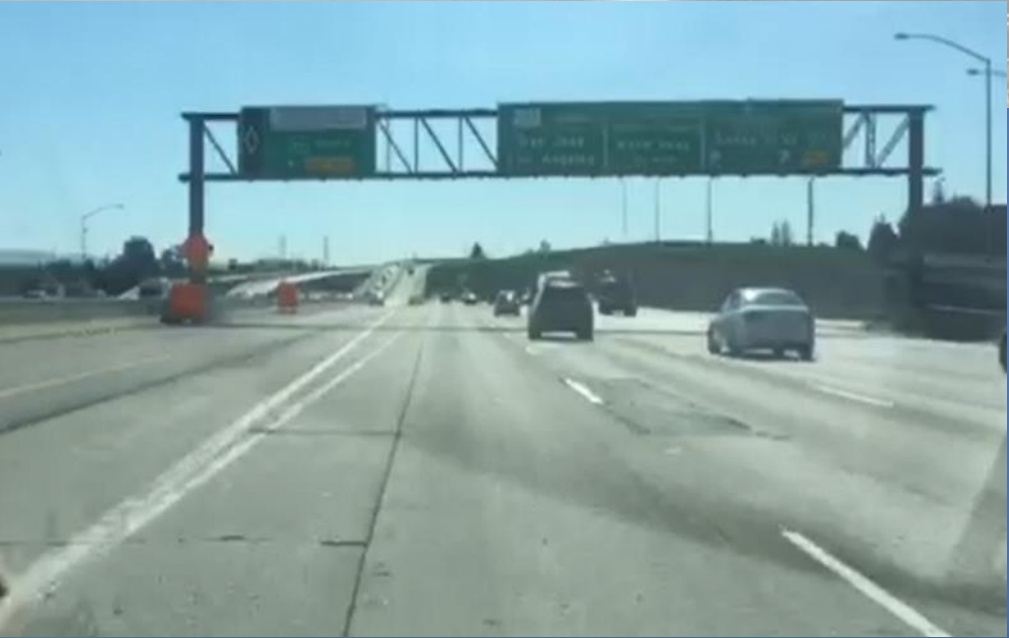
Crash Sequence

Time to crash: 7.9 seconds
Speed: 64.3 mph
Lead vehicle: 83.7 feet
Distance to crash: 748 feet

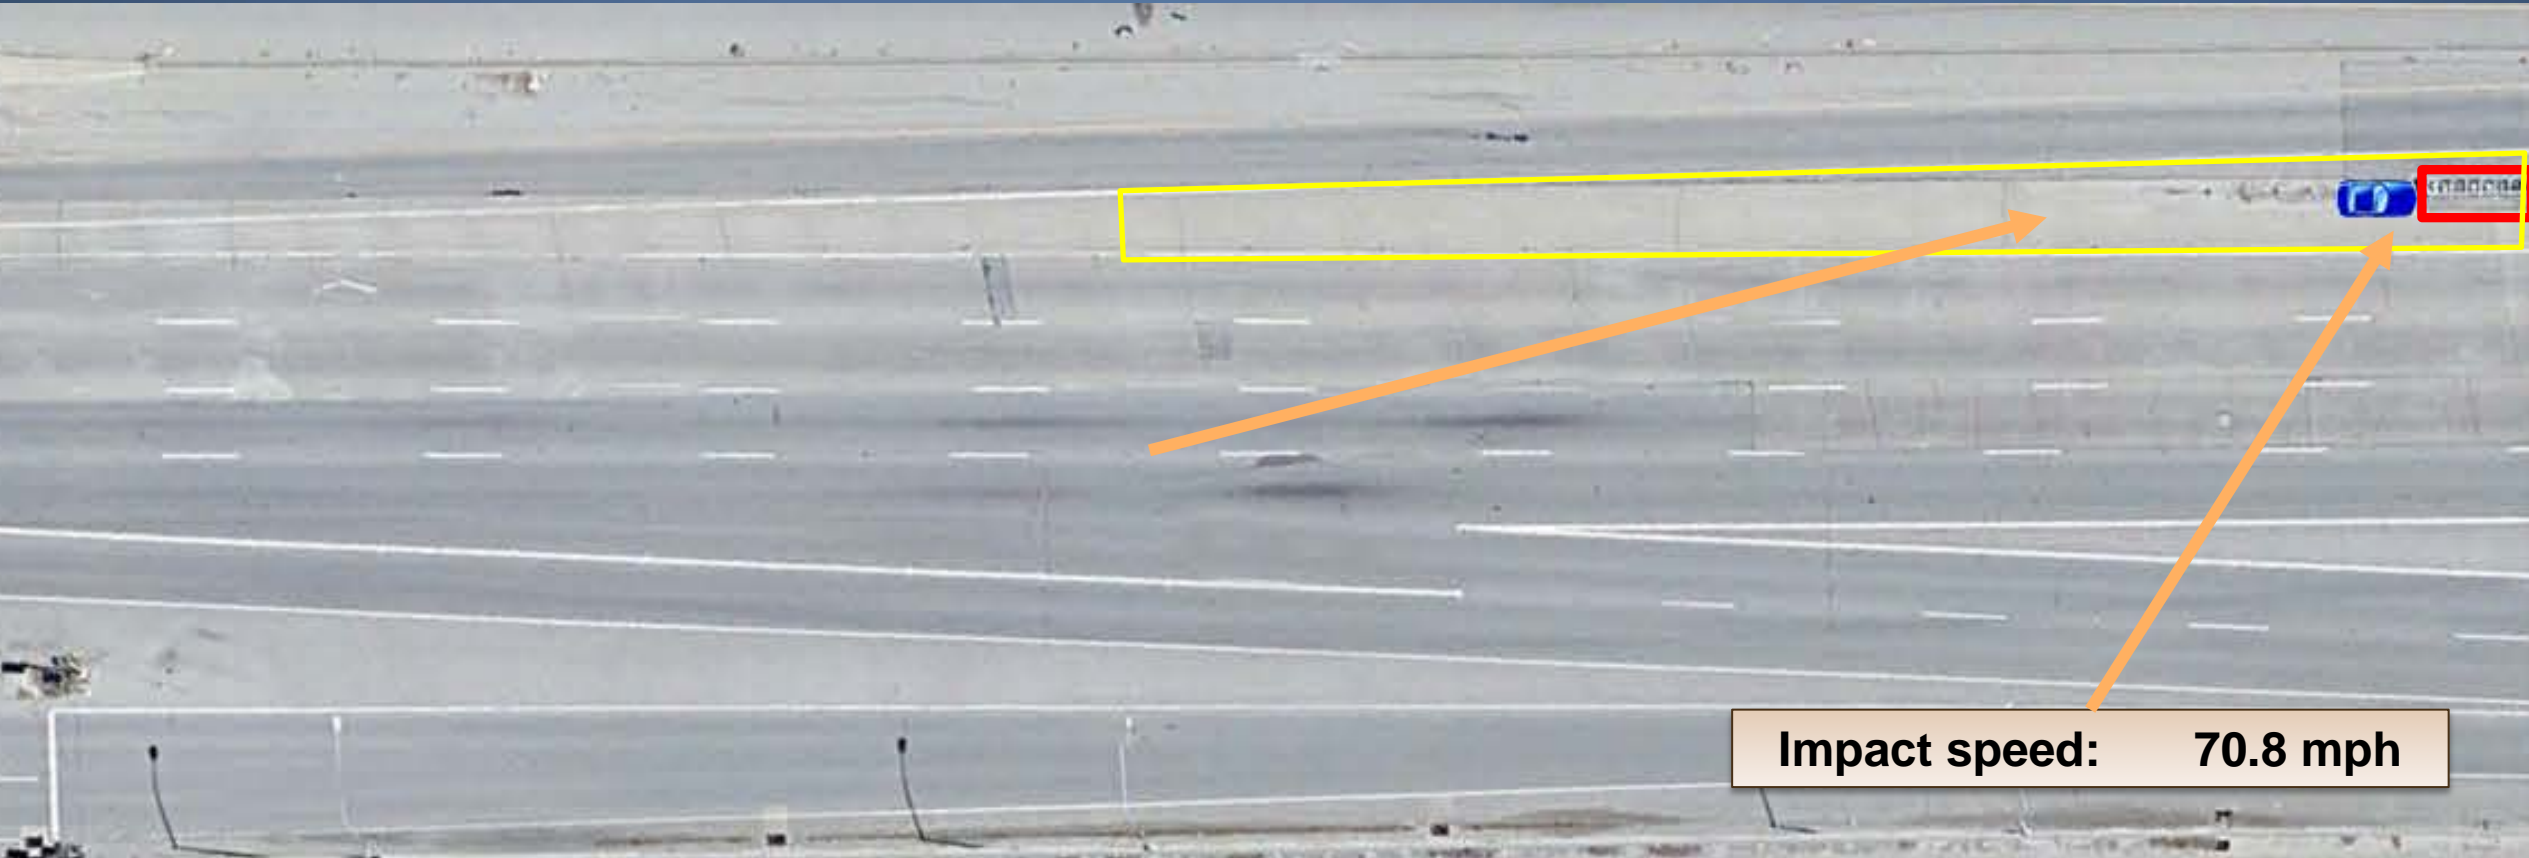
Crash Sequence

Impact speed: 70.8 mph

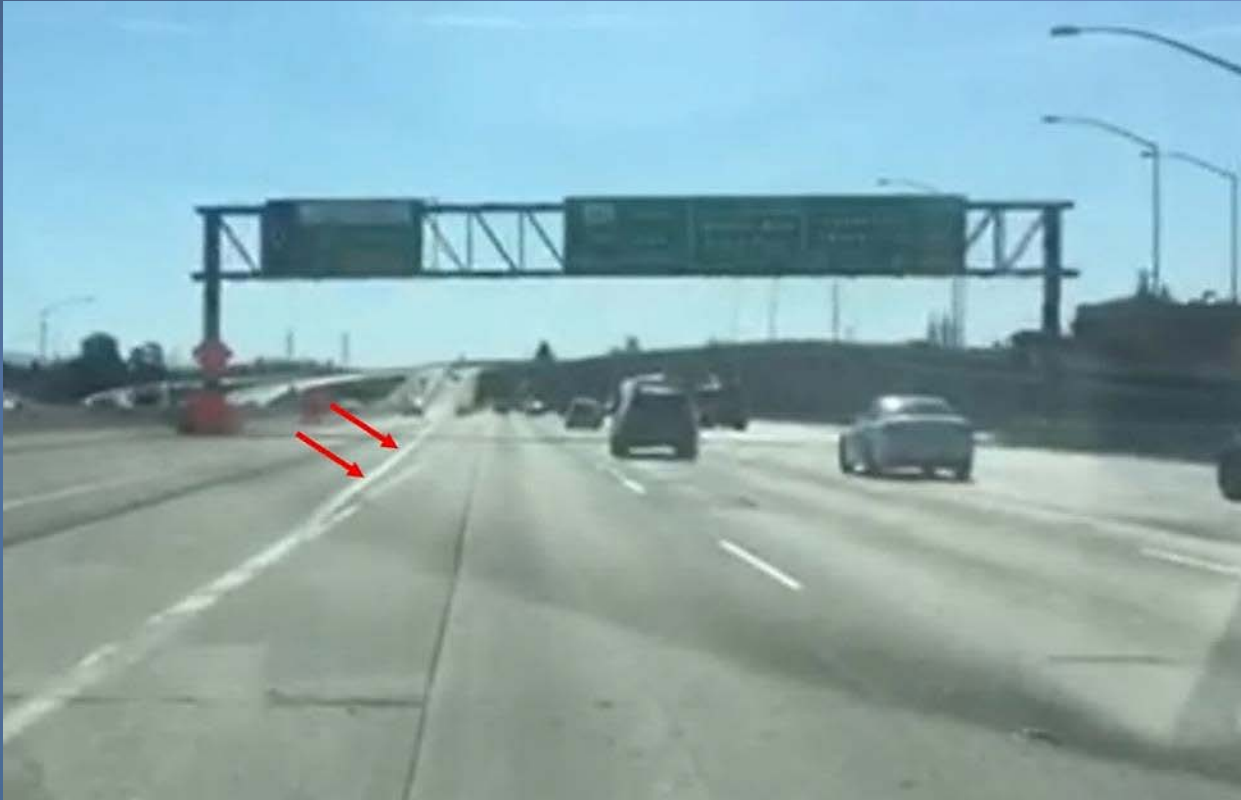
Autopilot Performance

- Lane markings were worn
- Autosteer vision system likely lost lane line prediction
- Identified stronger lane line
- Steering movement likely due to vision system limitations
