ACTIVE TRAFFIC & SAFETY MANAGEMENT SYSTEM FOR INTERSTATE 77 IN VIRGINIA

Mike McPherson, PE, PTOE
Regional Traffic Signal and Freeway Operation Engineer
Virginia Department of Transportation – Southwest Regional Operations

June 25th, 2019 NOCoE Road Weather Management Peer Exchange

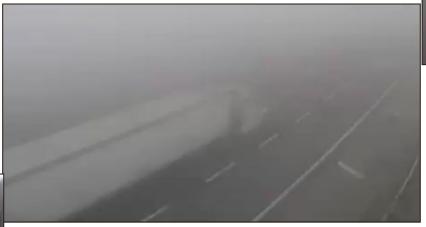
MM 4.3, Visibility 430 ft

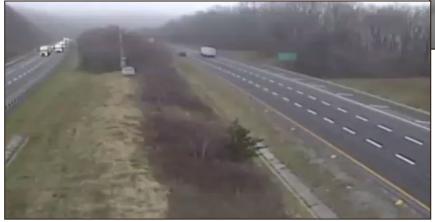
MM 1.9, Visibility 2000 ft

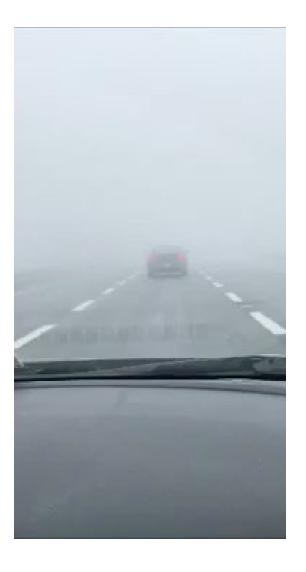
View from the Field

About 400' Visibility
